# LESSONS LEARNED IN INNOVATIVE STORMWATER BMP DESIGNS

## SIMPLE AND EFFECTIVE TECHNOLOGY APPLICATIONS

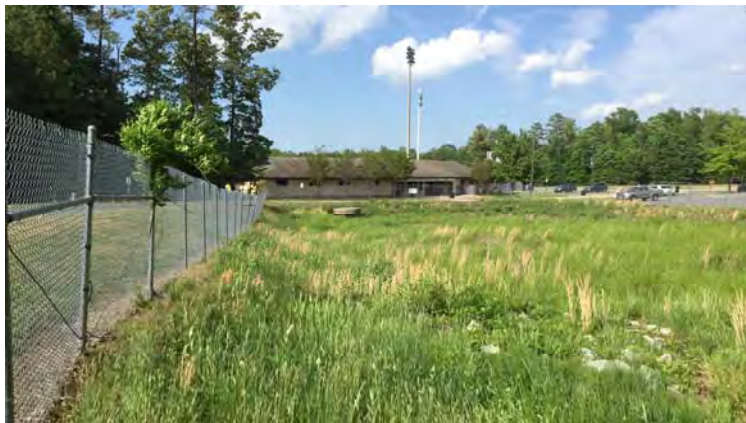
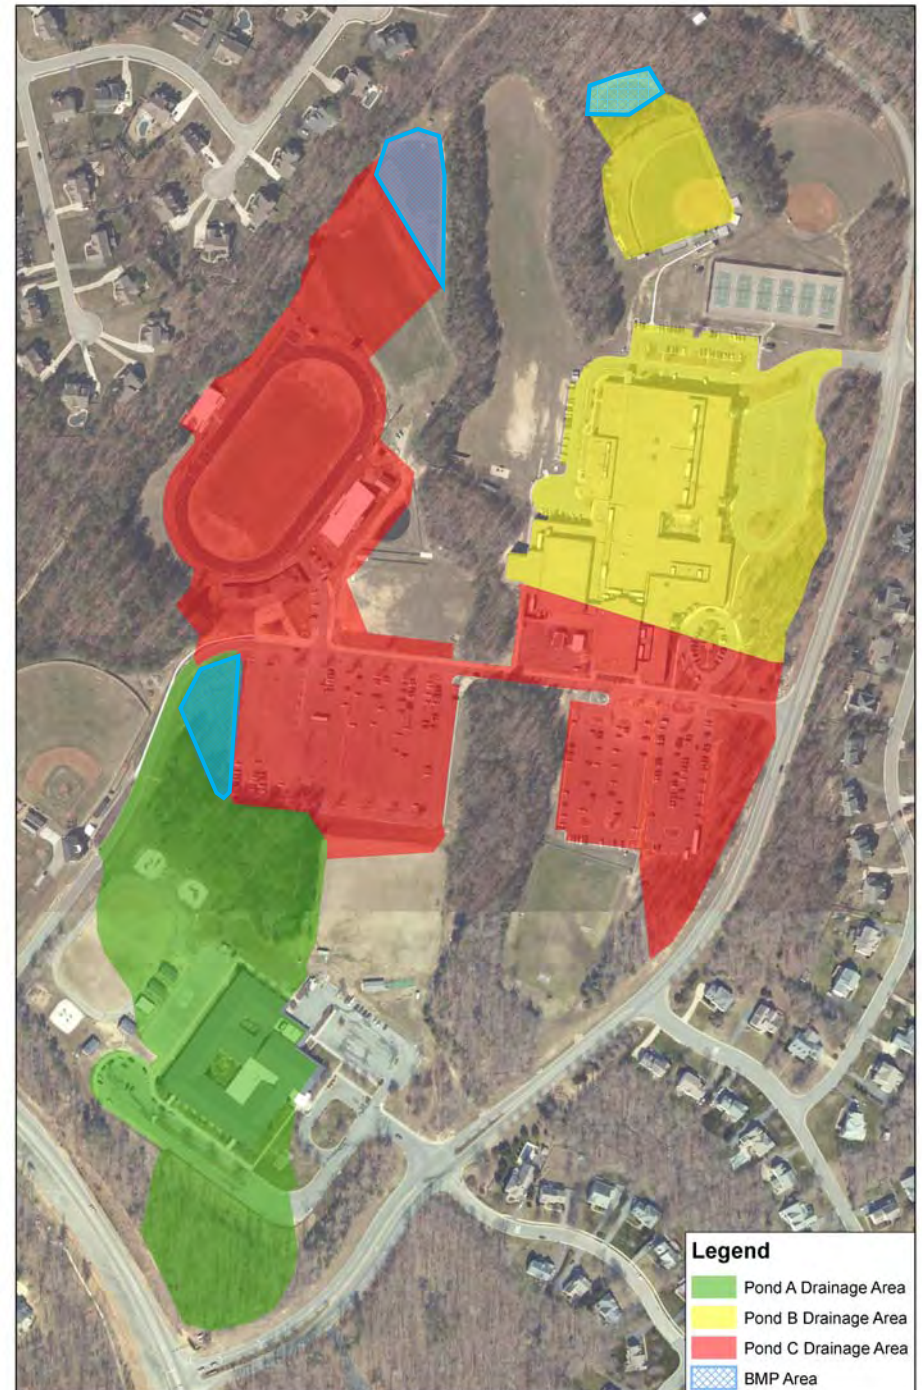
## James River High School

- Retrofit of 3 dry extended detention ponds to:
  - Constructed Wetlands
  - Wet Pond Level II
  - Wet Pond

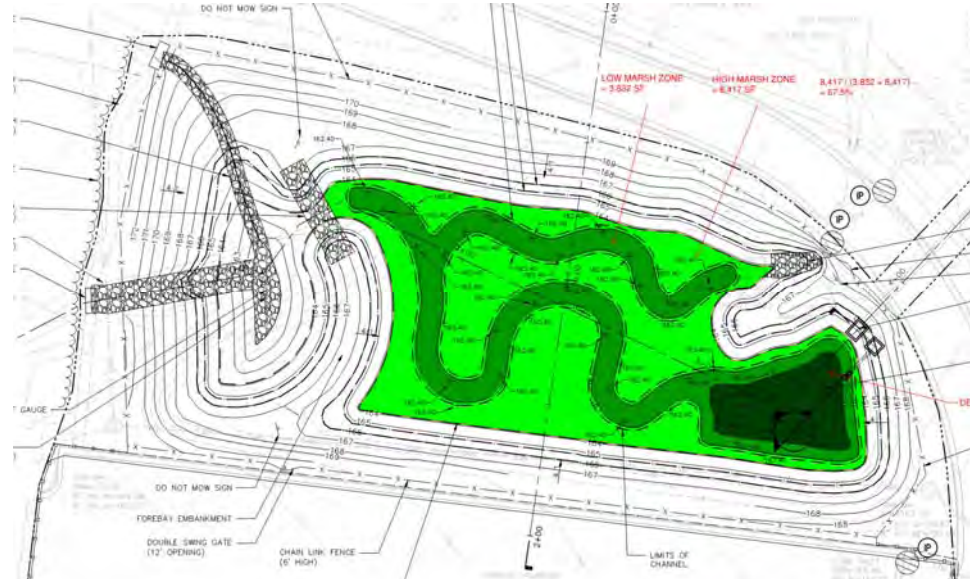
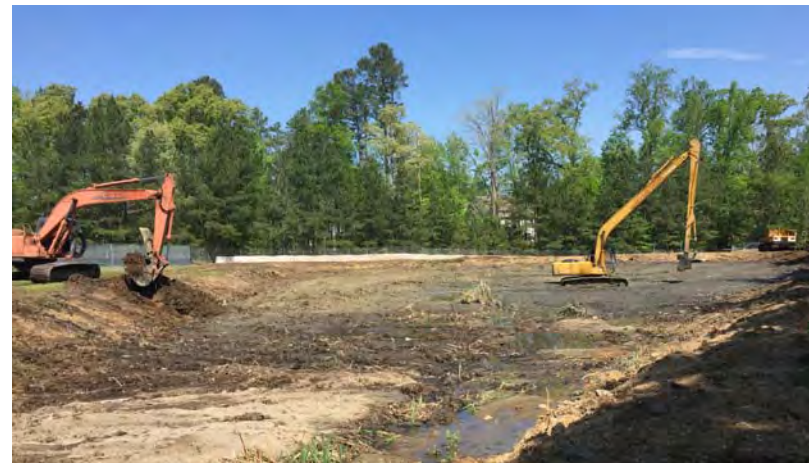
## James River High School

- Sedimentation over 20 years led to loss of functionality
- Enhancements to maximize pollutant reductions (TMDL credits):
  - Increasing volume
  - Removing paths of short circuiting
  - Adding forebay
  - Adding micropool
  - Wetland plantings

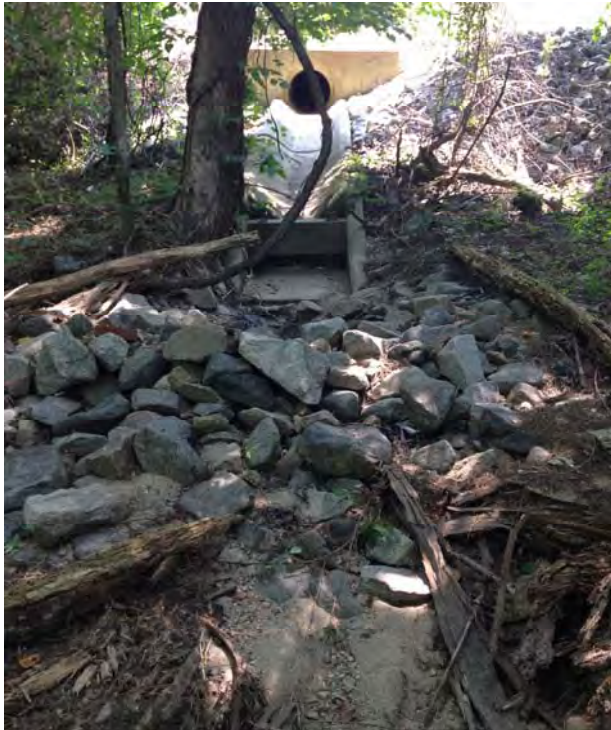
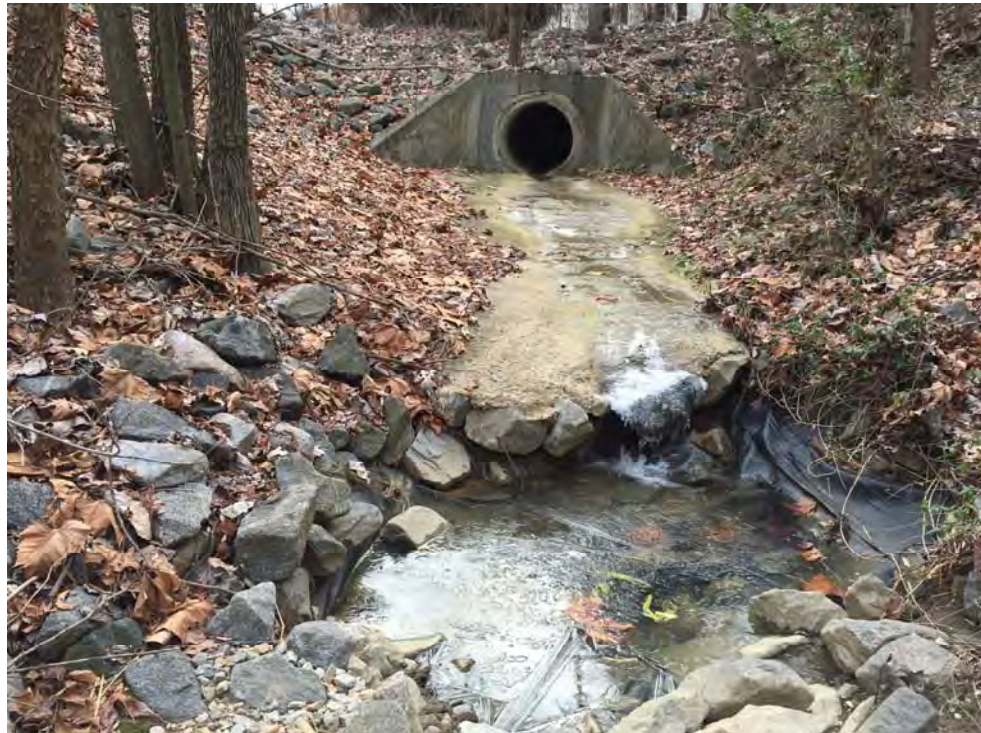
## Outfall Retrofits Proctors Creek WWTP

- Retrofit of 2 large diameter outfalls (30" and 42")

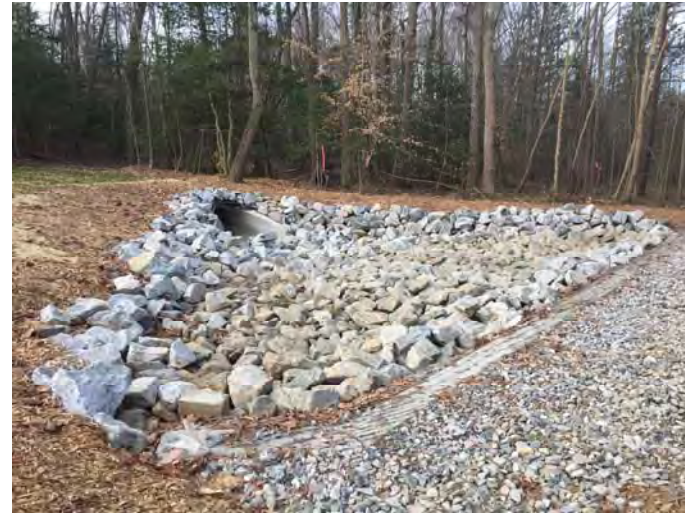
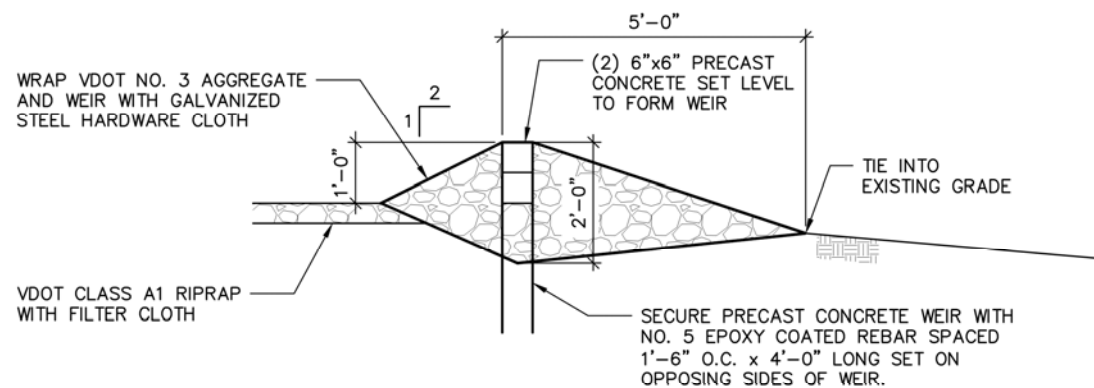
SPREADER WEIR DETAIL

- Highly cost effective
- Small footprint
- Sites with no existing treatment

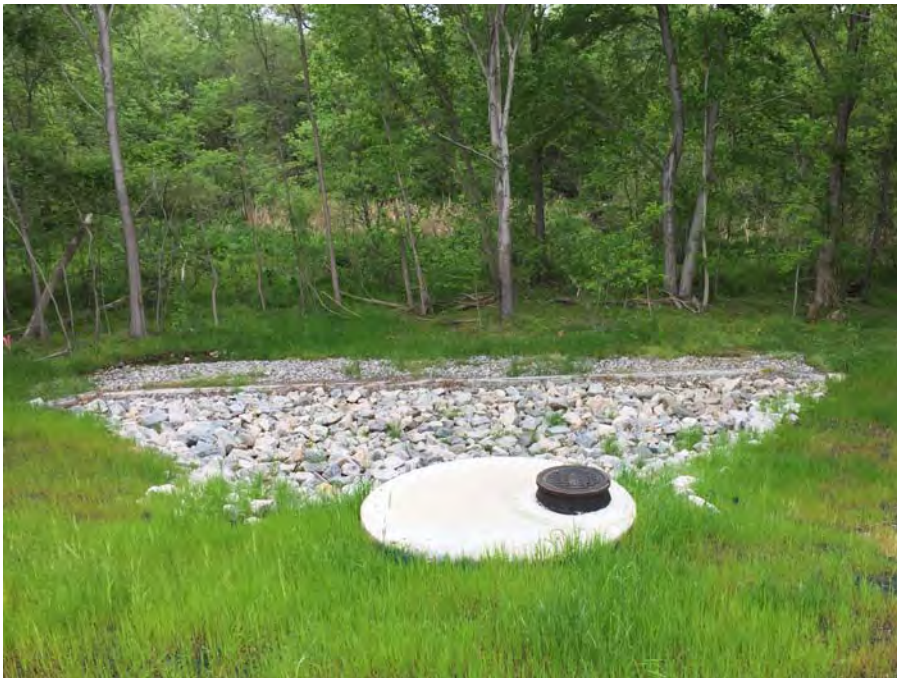
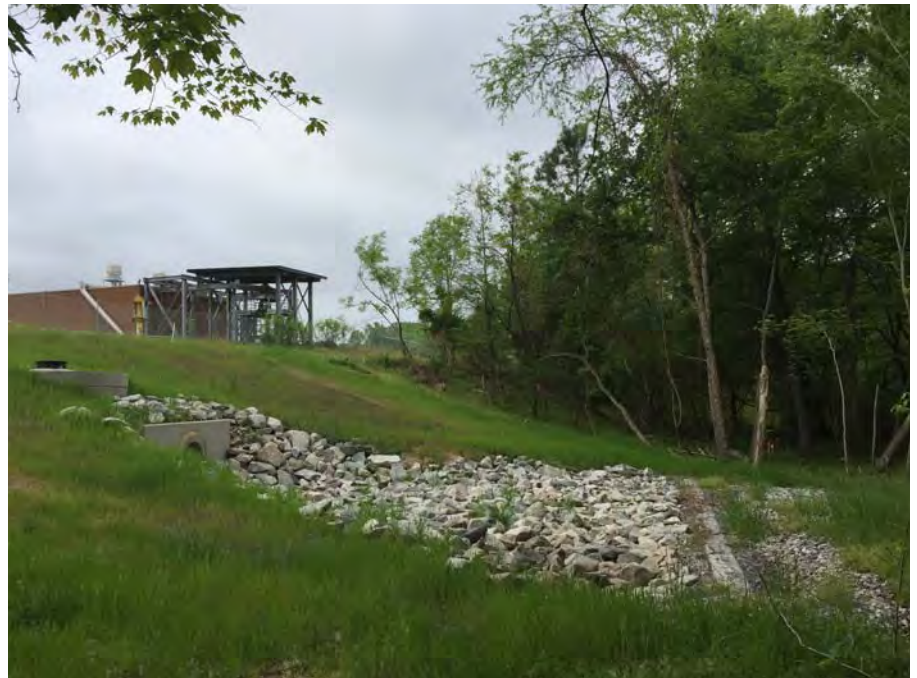
# Outfall Retrofits Proctors Creek WWTP

- Completed 30" Outfall Retrofit

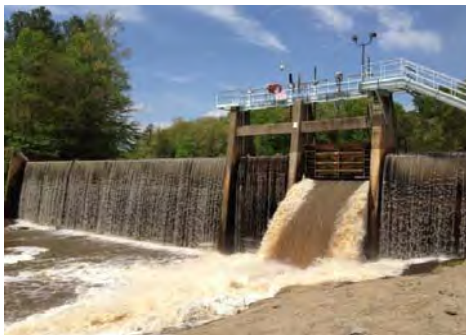
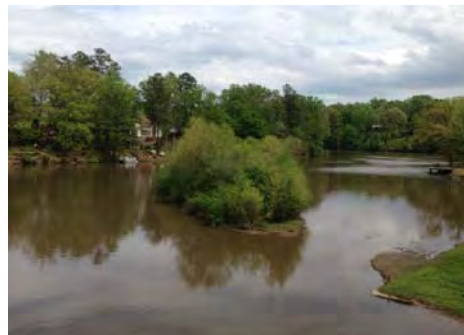
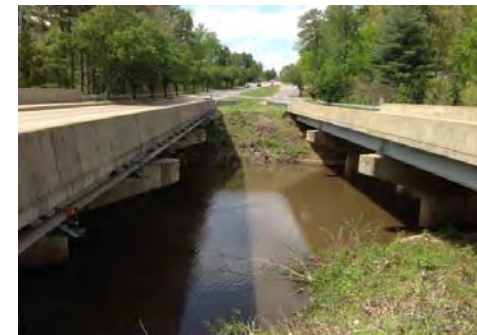
## Falling Creek Reservoir

- 34,000 acre watershed
- Highly developed
- Constructed in 1951 for water supply, but has not been used since 1985
