ELLICOTT CITY PARKING LOT E

Urban Retrofit Design - Howard County, Maryland

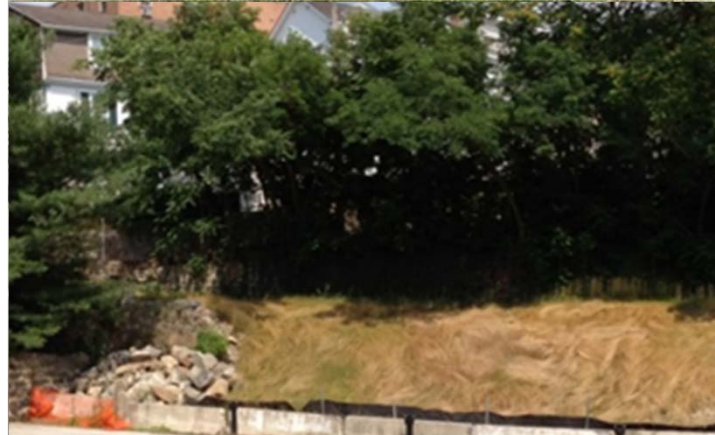
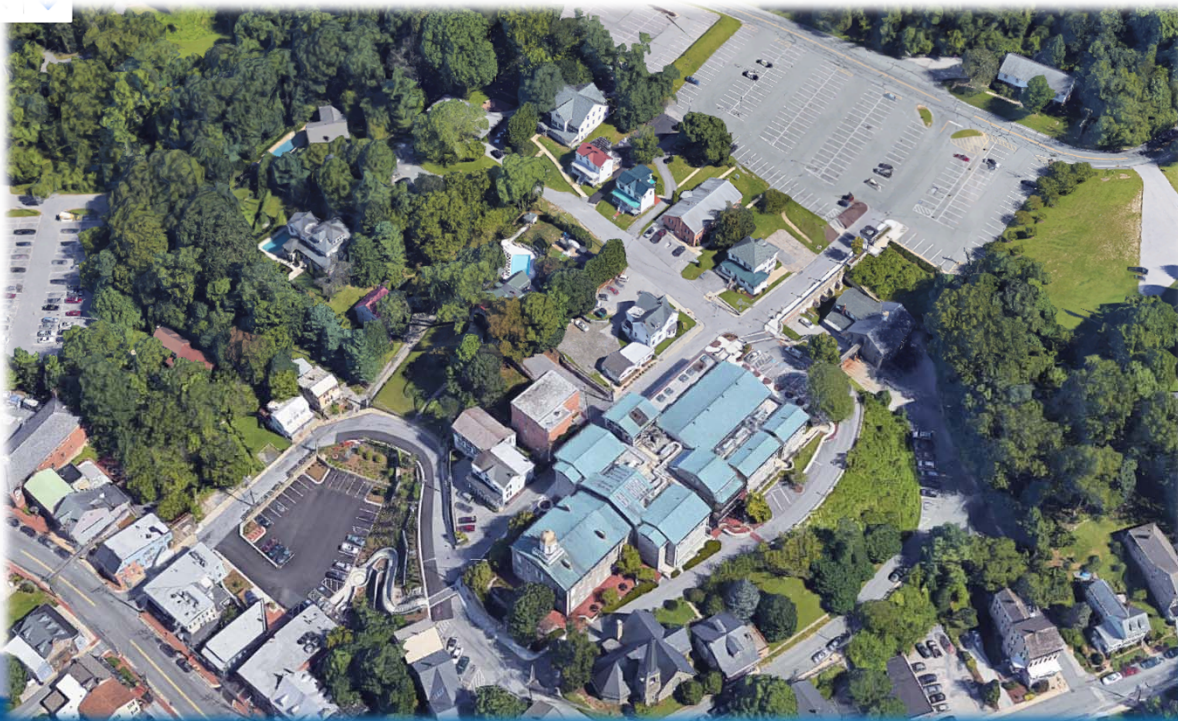
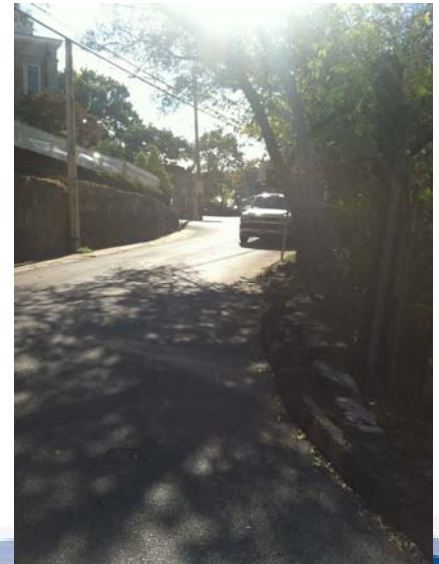
Initial Project Evolution

1. Failed Retaining Wall
2. Connection to Parking
3. Desire for Water Quality

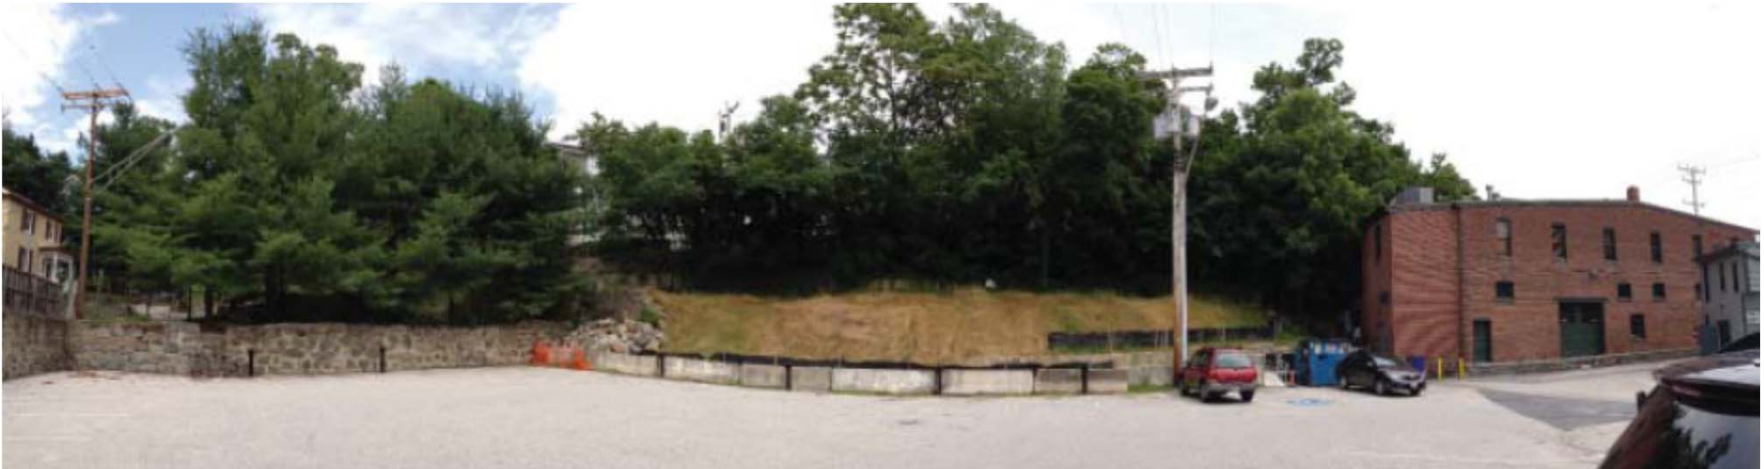
Project Components: Water Quality

- Site features steep slopes and confined channel surrounding pavement
- Need to maximize parking
- Soils and bedrock unfavorable for pervious pavement

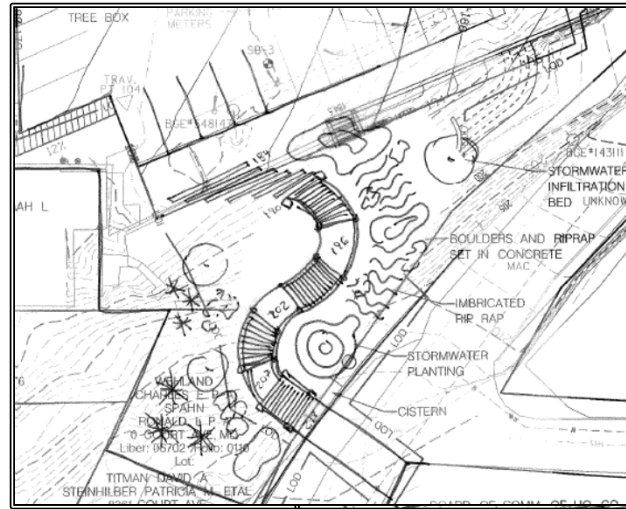
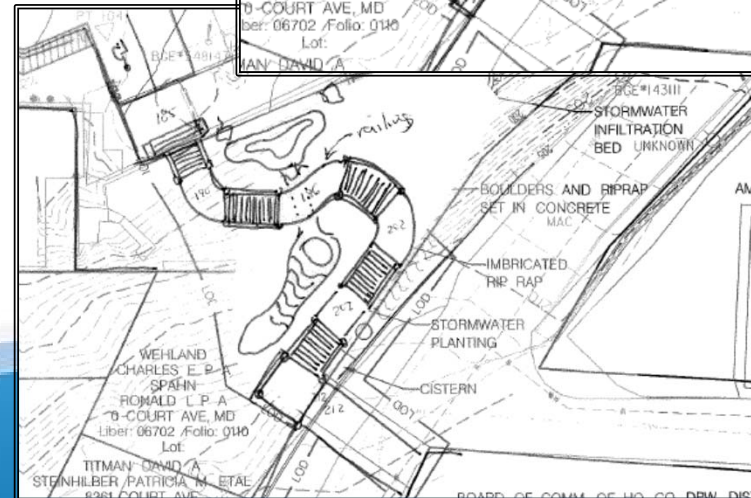
Project Components: Staircase / Retaining Wall

- Shorten the walking distance from Courthouse to Main St.
- Works in concert w/ retaining wall repair
- Provides opportunity to incorporate water quality features into the slope

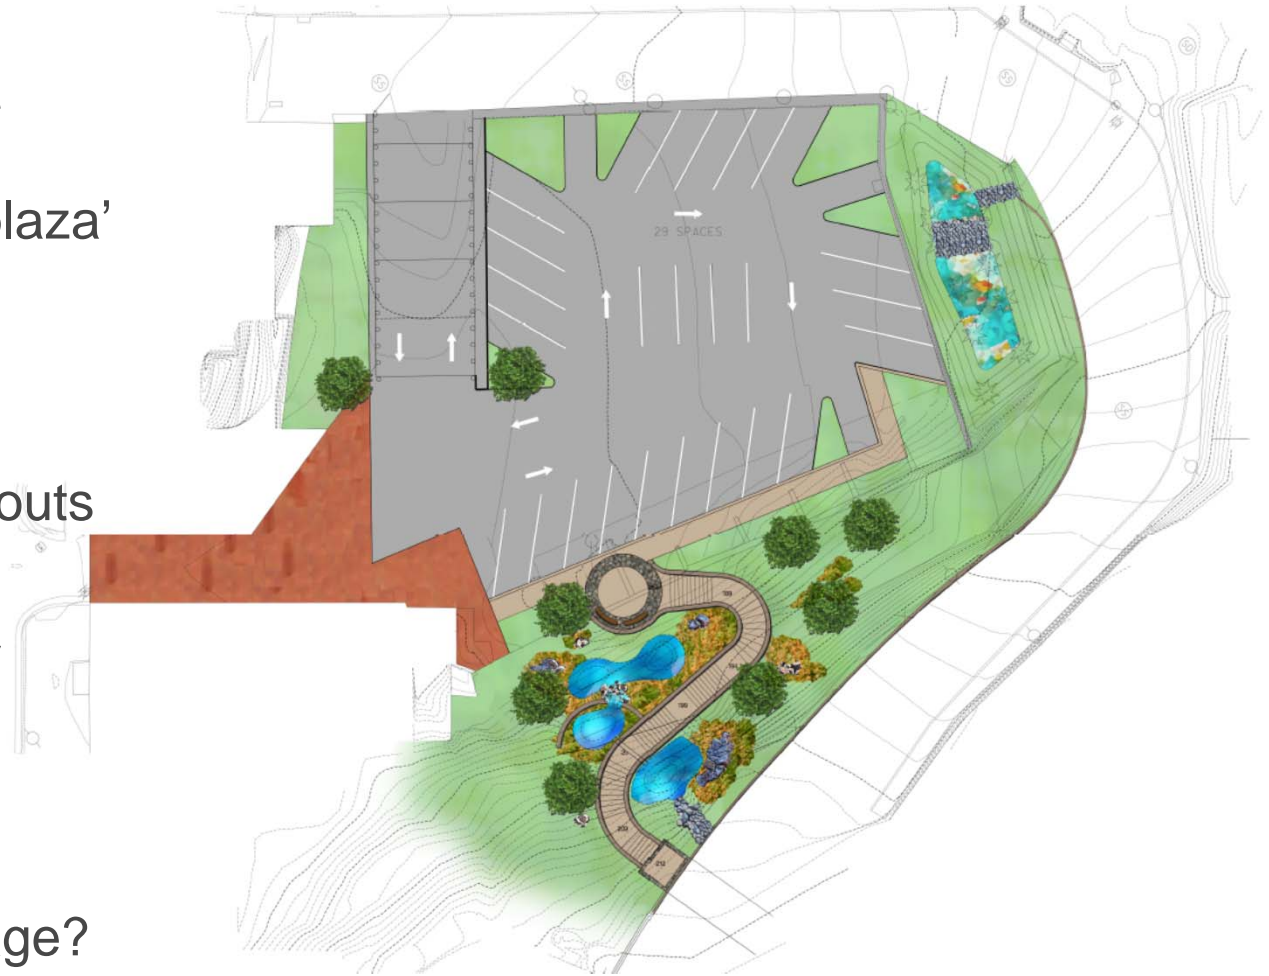
Project Concept

- Turn entrance into 'plaza' area adjacent to restaurant
- Several Parking Layouts
- 'Tiered' water quality along slope...

...but how to address grading to create storage?

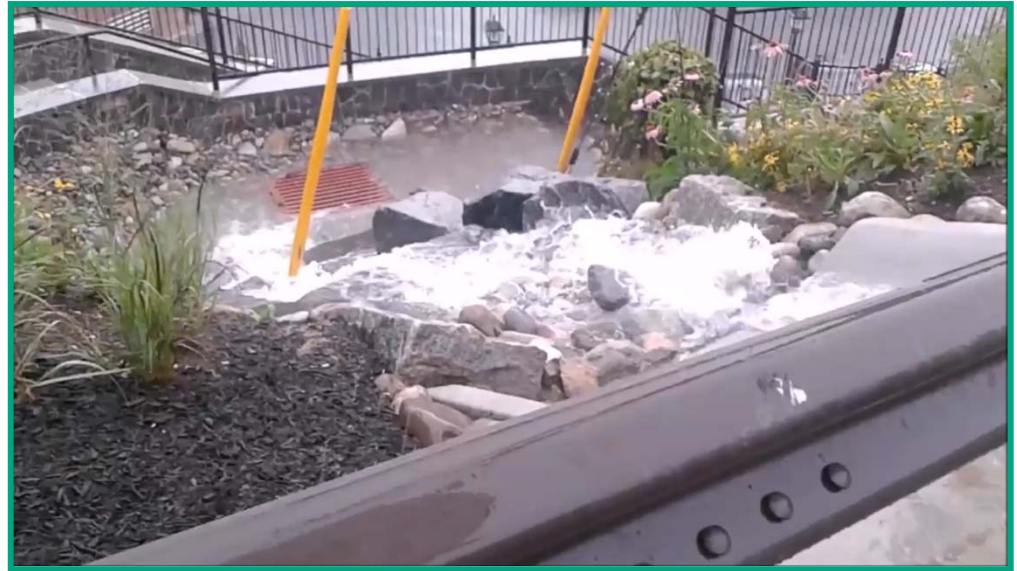
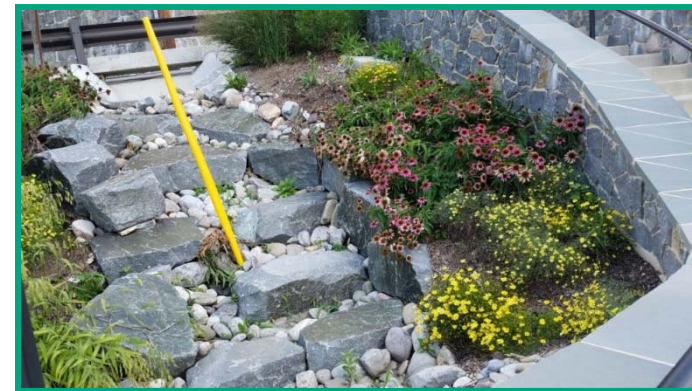
Staircase BMP

- Top Stage
 - Capture initial flow from Courthouse Area
 - Step pool to forebay inlet
 - Work around anchor wire

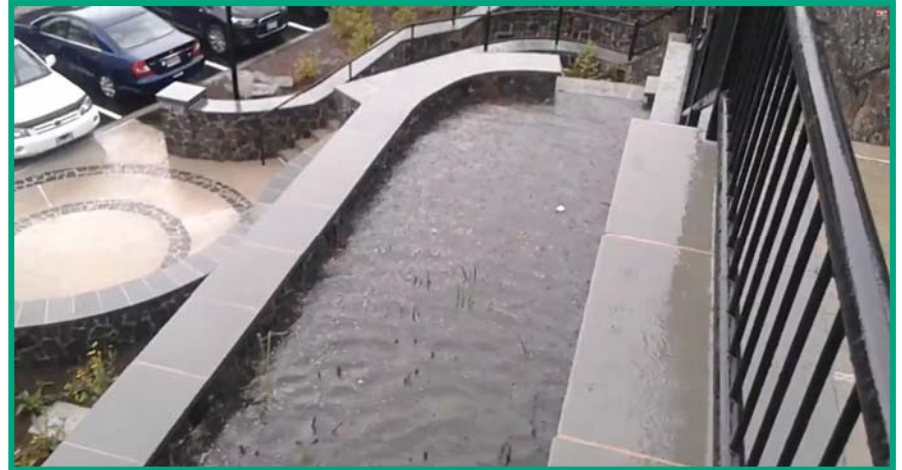
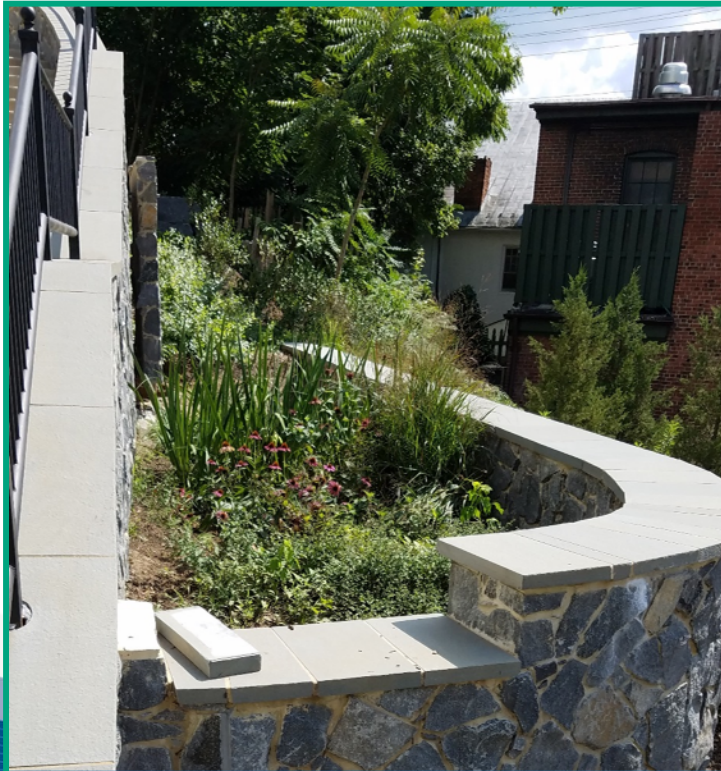
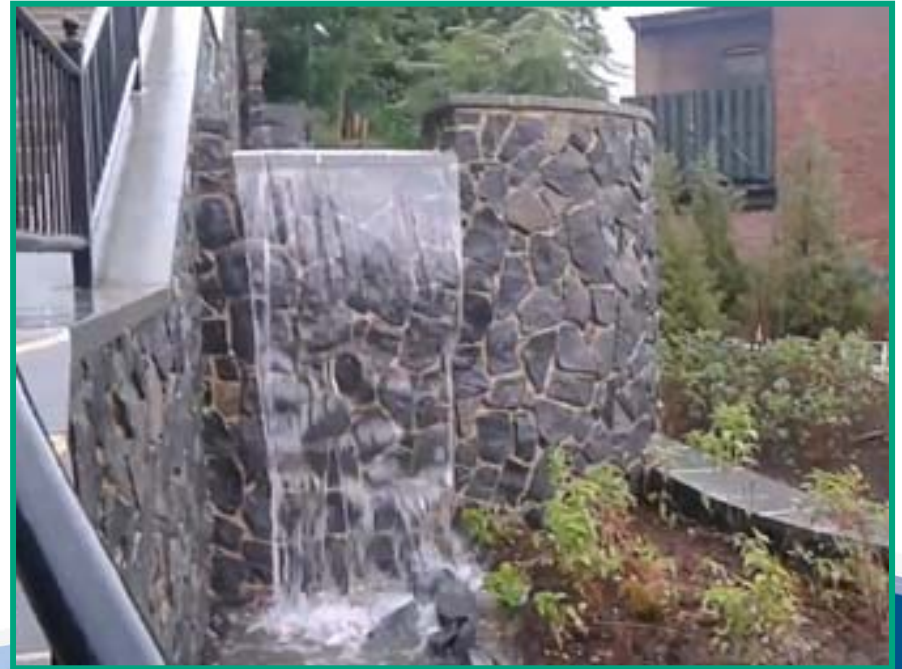
Staircase BMP

- First Bioretention
 - Pipe from forebay hits panel and drops down
 - Overflow goes into “turn channel”

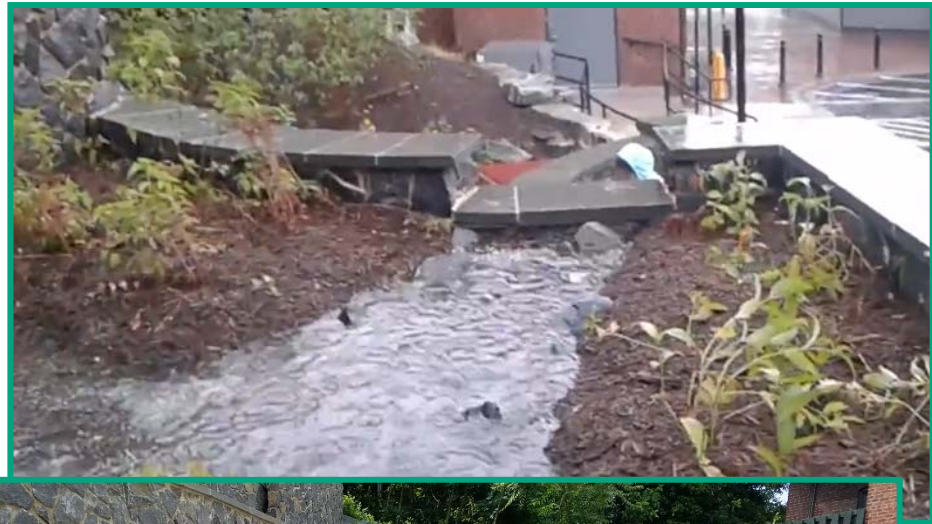
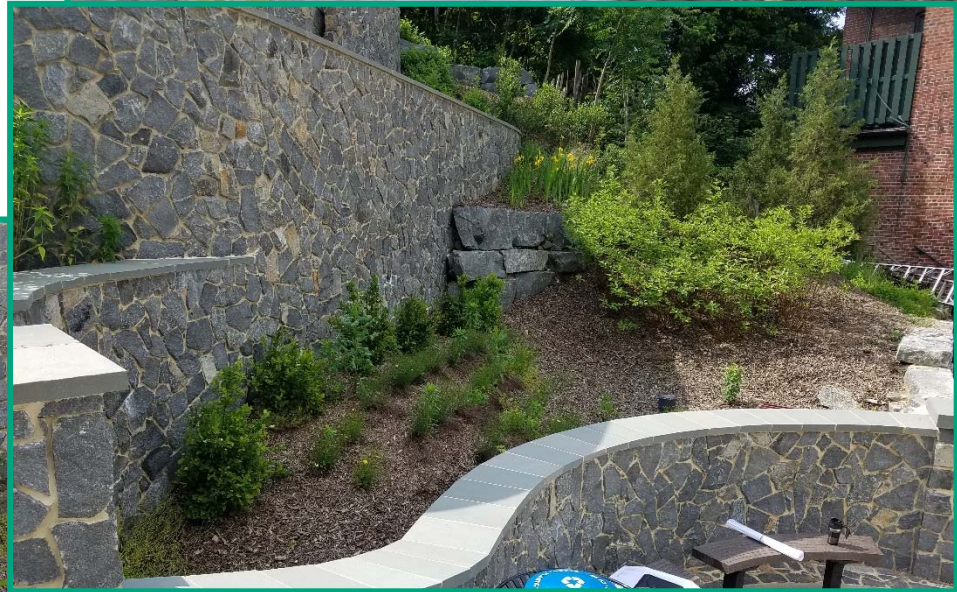
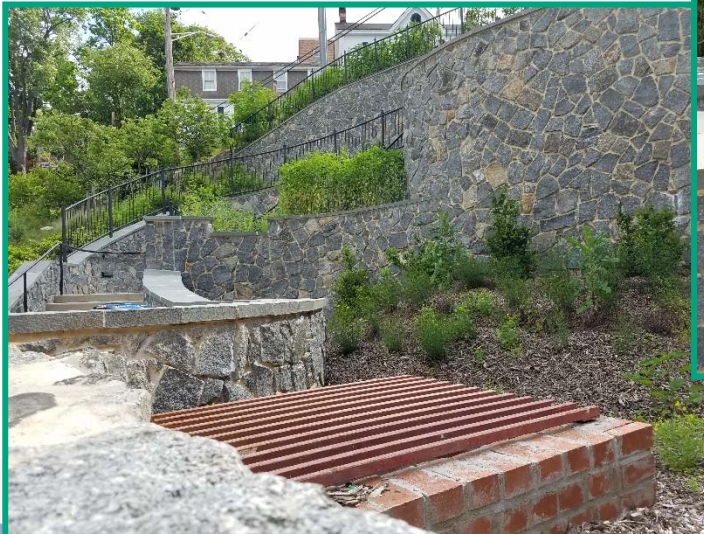
Staircase BMP

- Second Bioretention
 - Receives flow from “turn channel”
 - Collects underdrains from above, ties into lot storm drain

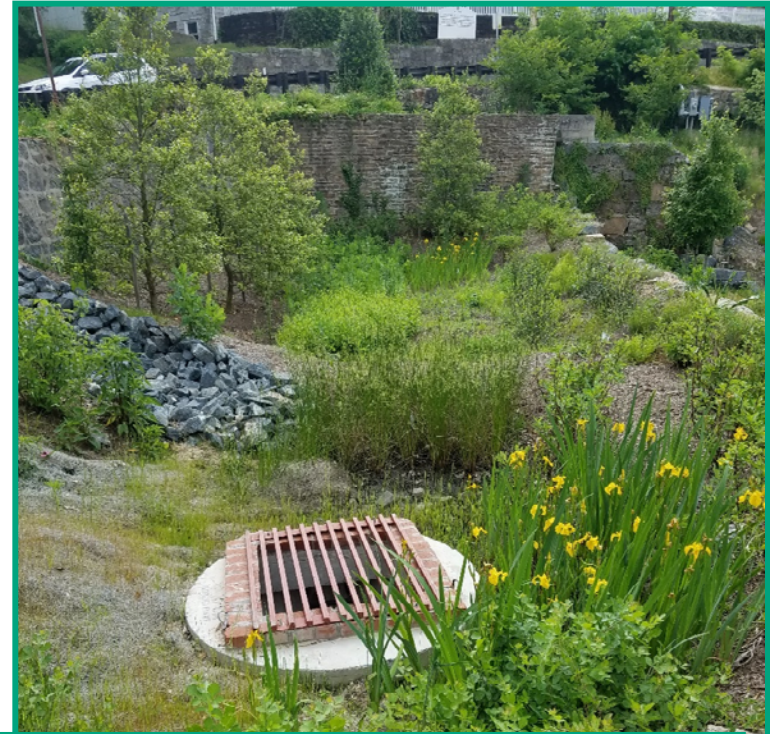
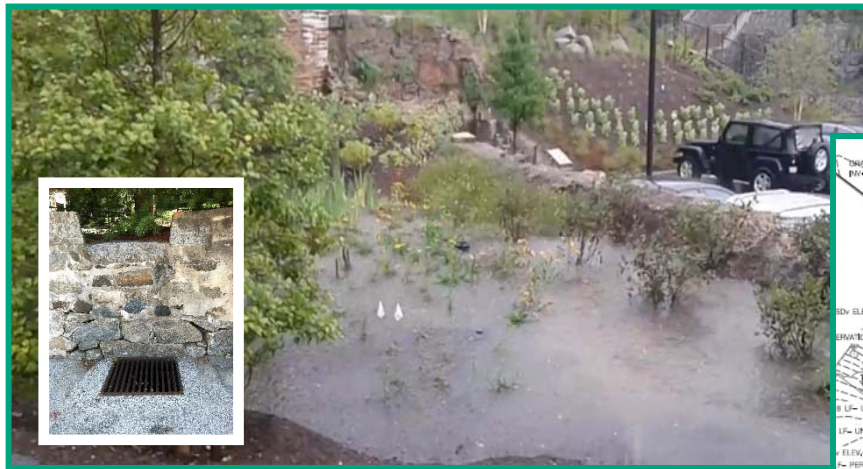
Terrace BMP

- Receives Bypass Flow, Court Ave
 - Set behind wall at north end of lot
 - Overflow into forebay inlet
 - Additional weir onto lot above inlet

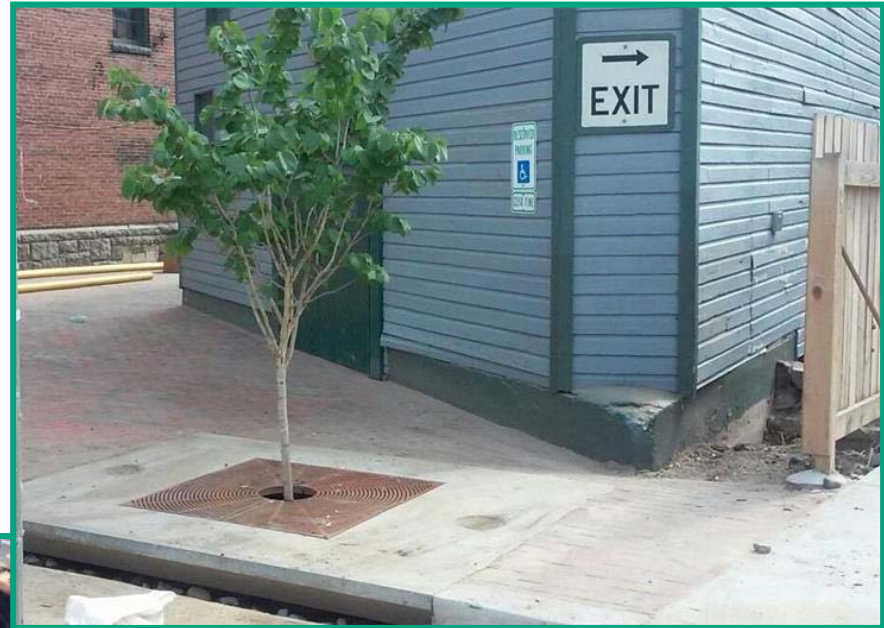
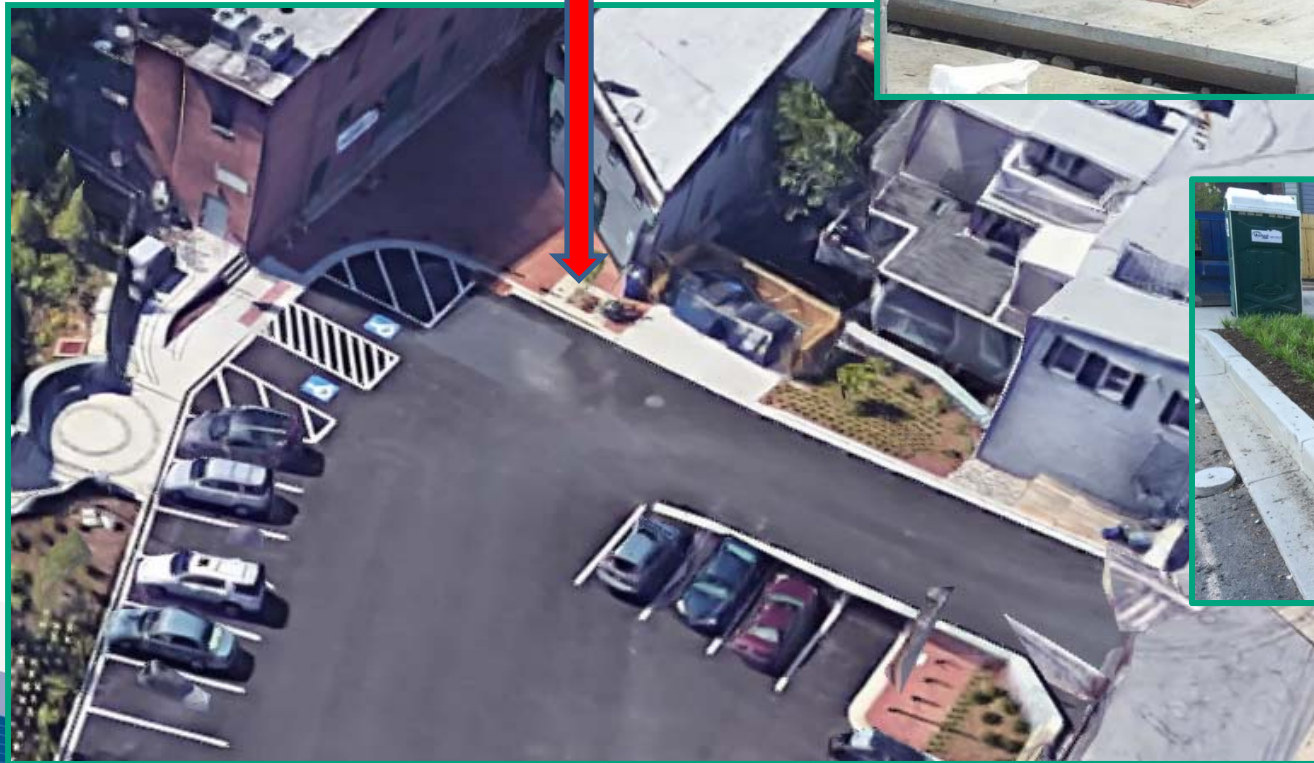
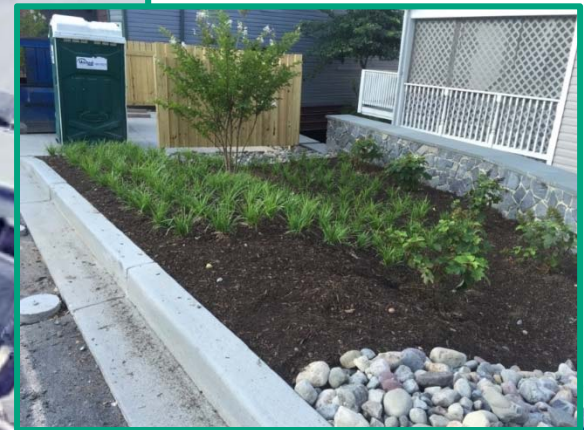
Filterra™ Tree Box

- Receives Flow from Lot
 - Bioretention option too close to existing house
 - Filterra in plaza area

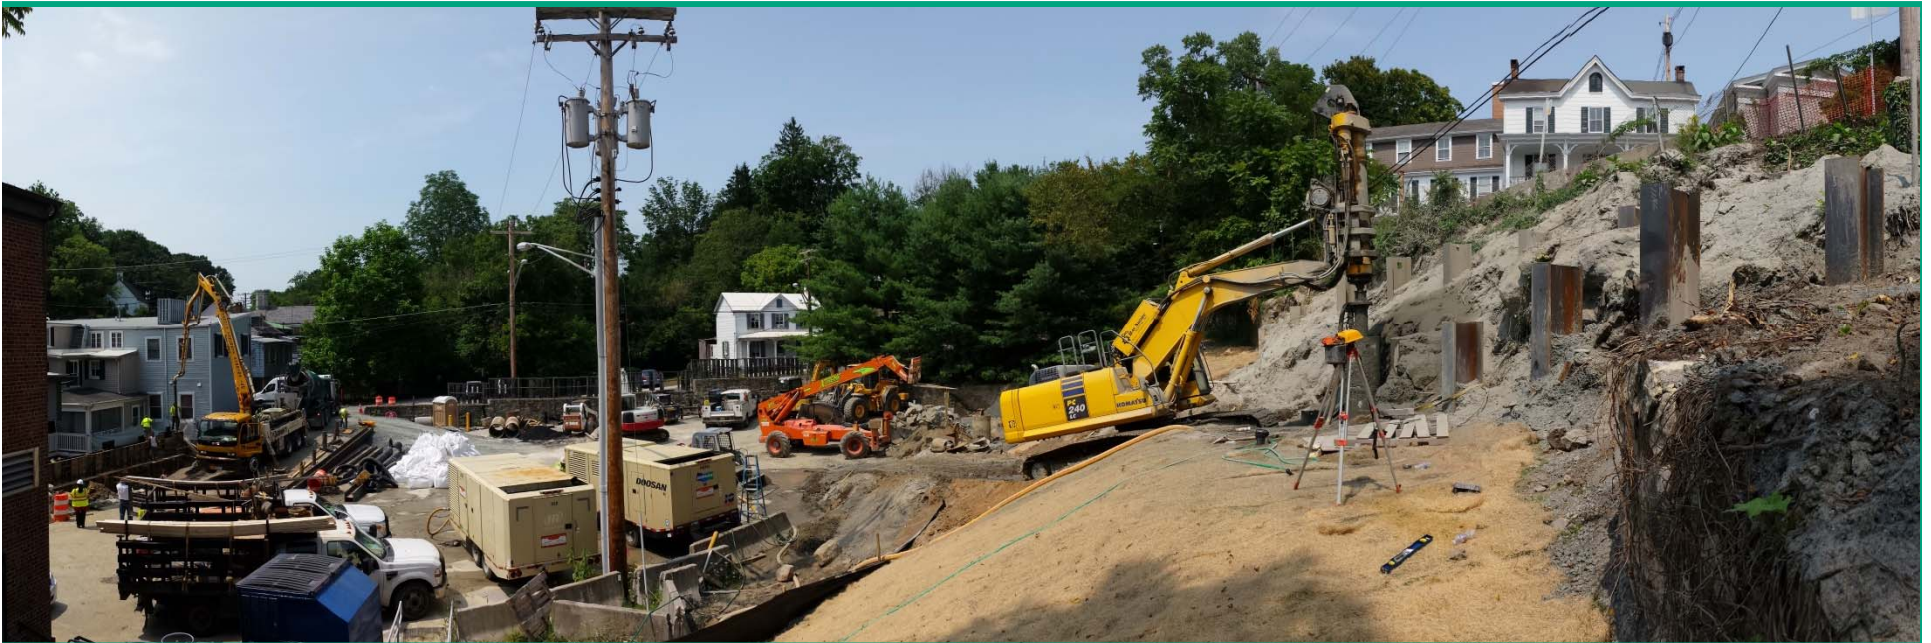
Wall Failure

- Expedited Timeline (Multiple Contractors)
 - Design: September 2013
 - Phase 1 Construction: May 2014 - September 2014
 - Phase 2 Construction: September 2014 – August 2015
 - Wall Collapse
 - Aging Infrastructure
 - Business Delivery Coordination

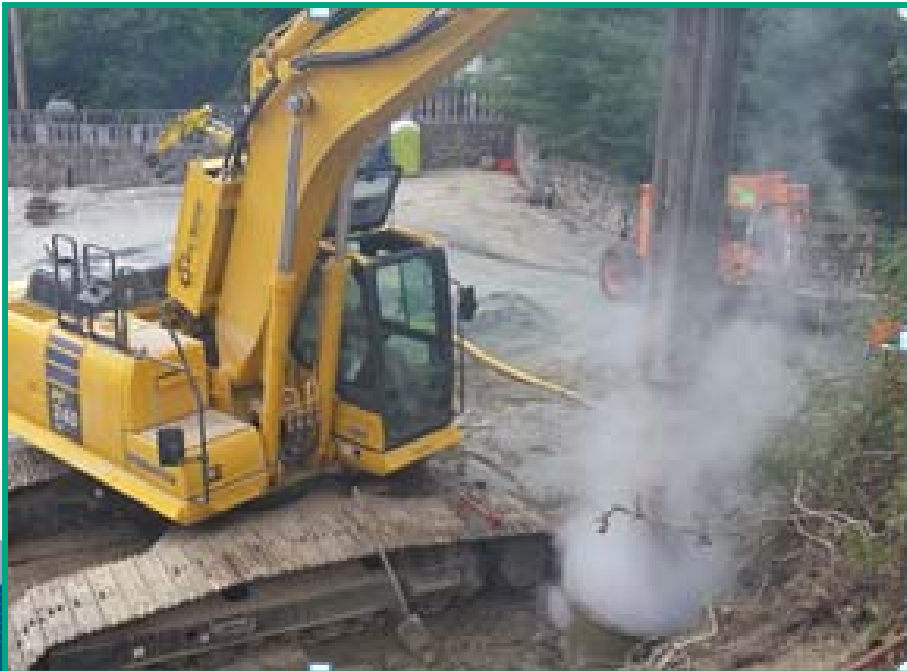
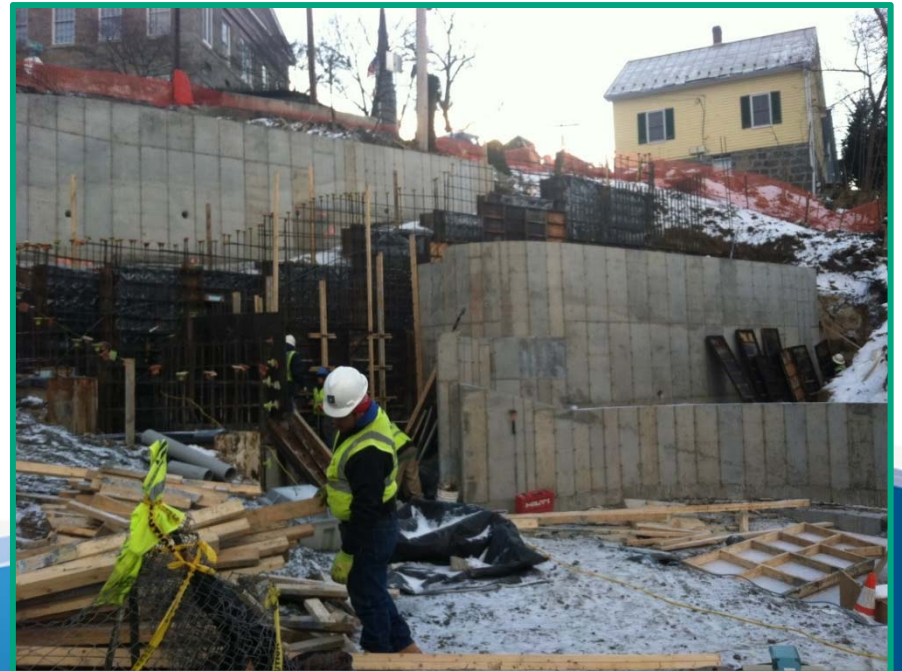
Structural

- Staircase/retaining walls
 - Phase 1 – Concrete caisson and soldier pile installation
 - Phase 2 – Concrete staircase and spread footer retaining walls
 - Large outcroppings of bedrock → Major rock excavation operation

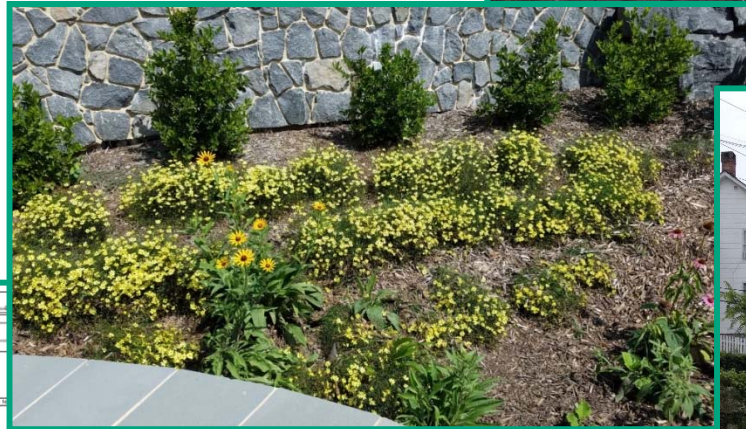
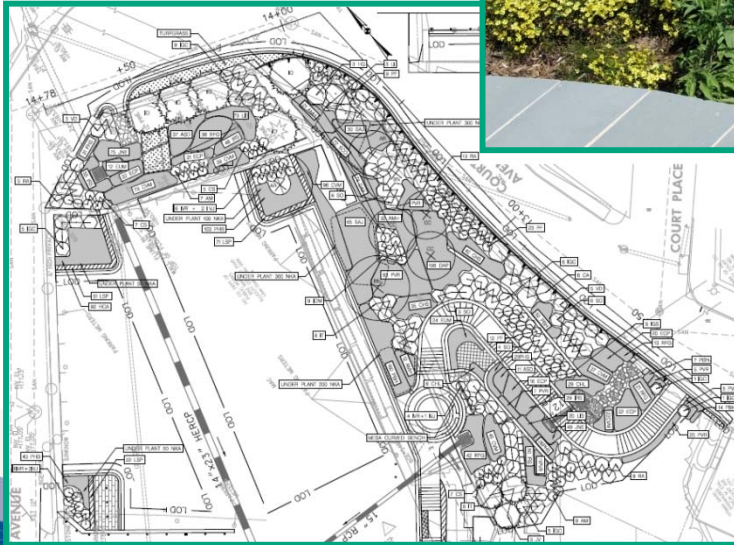
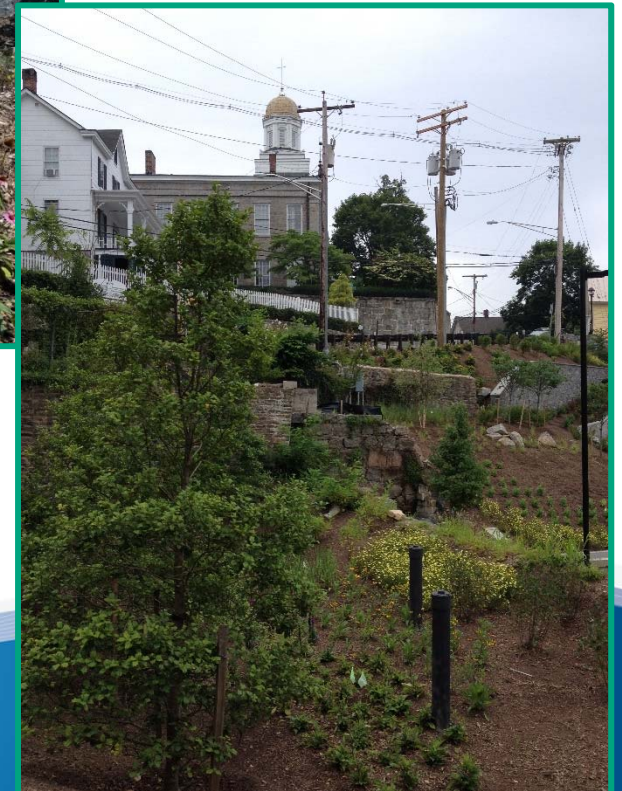
Landscaping

- Selection of native plants
- Salvaged stone materials
- Visual screening

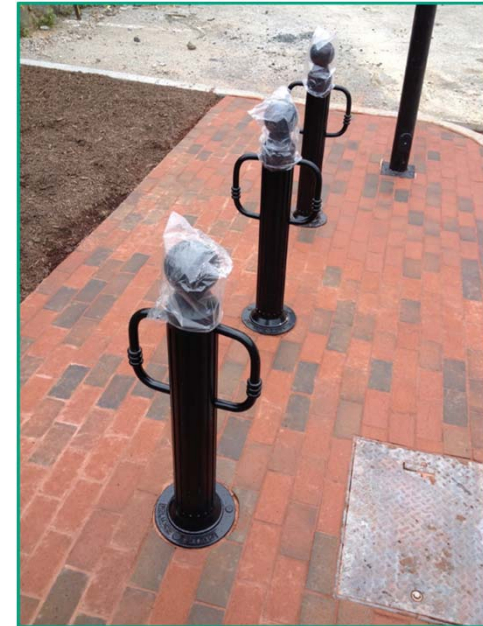
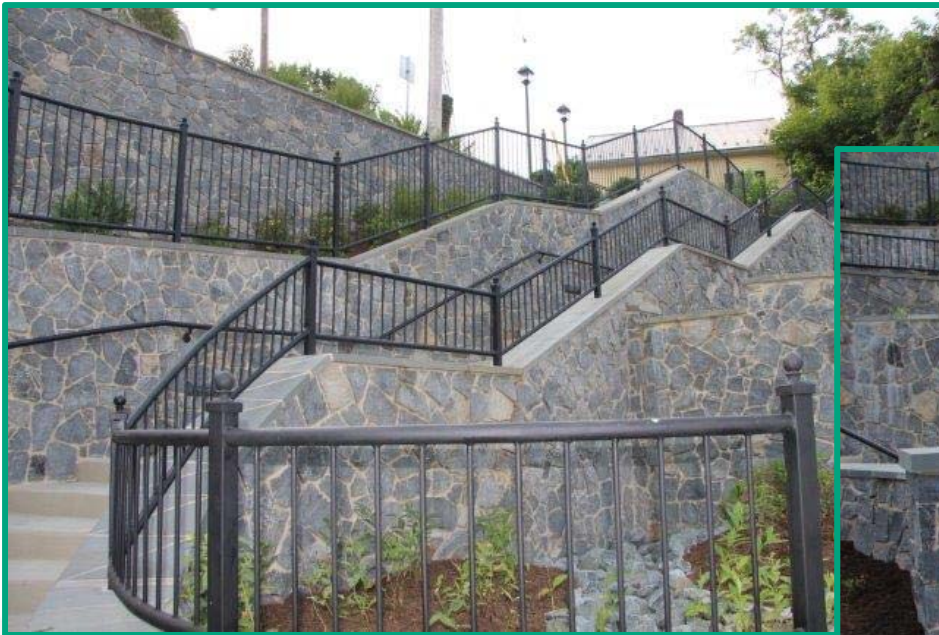
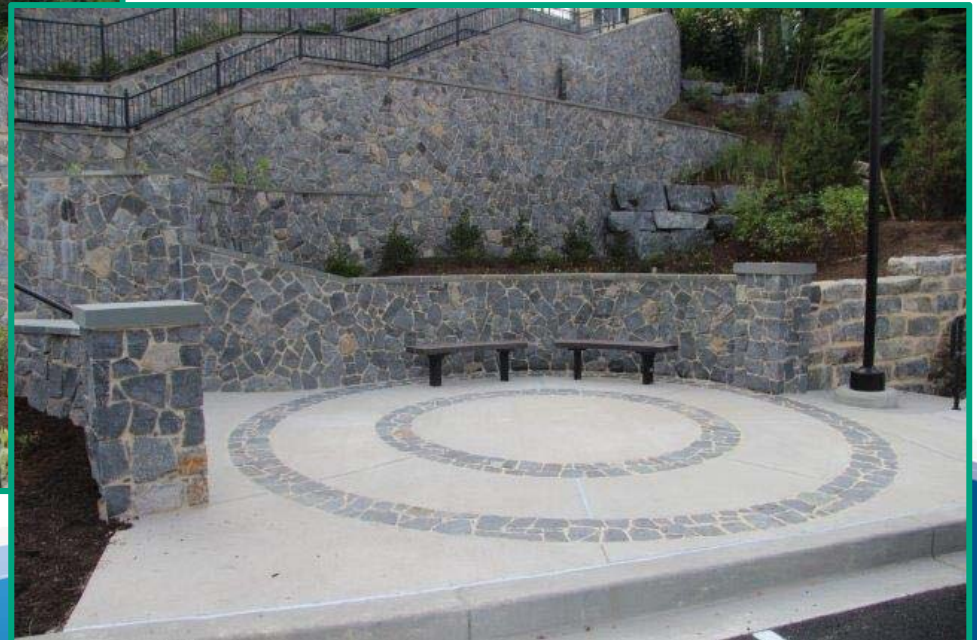
Hardscaping

- Used salvaged stone where possible (from failed wall)
- All architectural elements approved by Ellicott City HDC

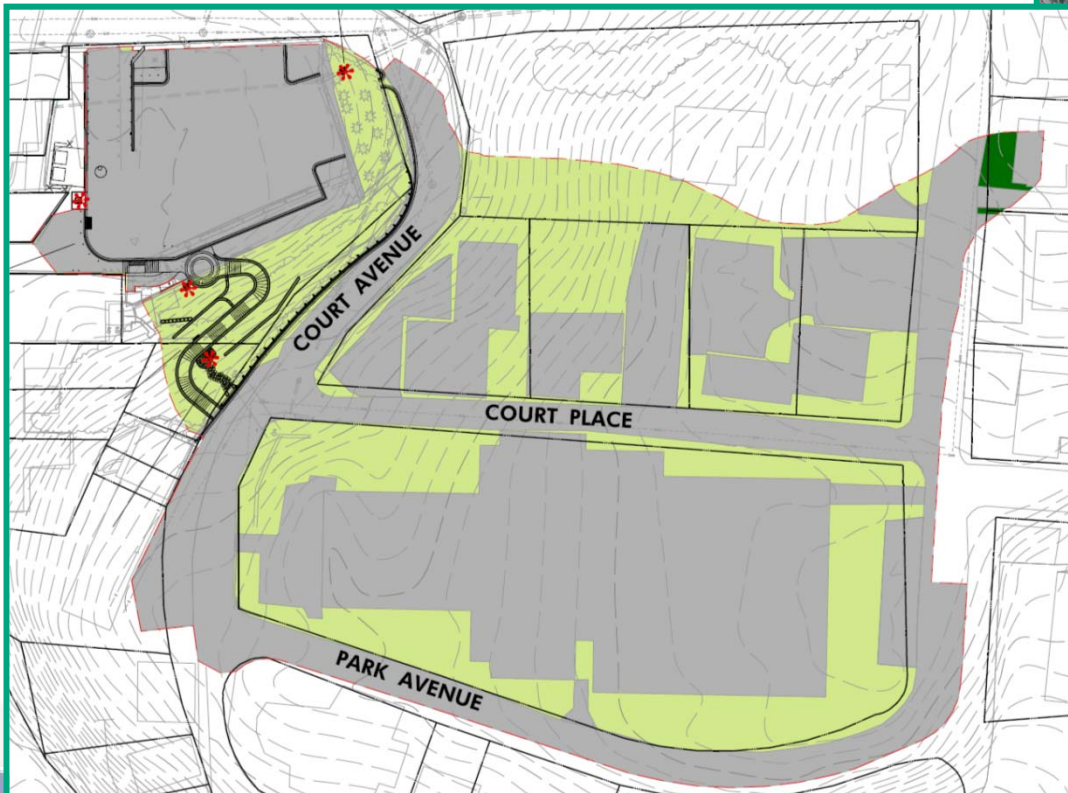
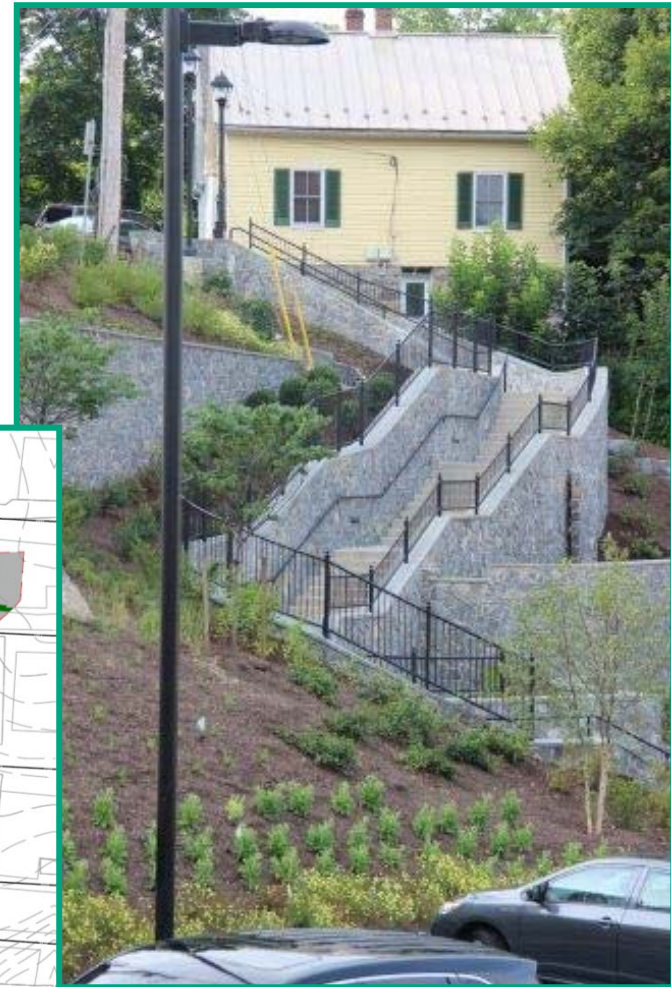
Water Quality Treatment

- Rooftop and pavement from courthouse area + majority of Lot E
- 2.72 Ac of impervious area
