Receiving Streambank Regeneration Through Upland Hydrologic Restoration

CWEA Webinar

Modified, Enhanced, and Enlarged Sand Filters as
Retrofits of Existing Stormwater Management Ponds

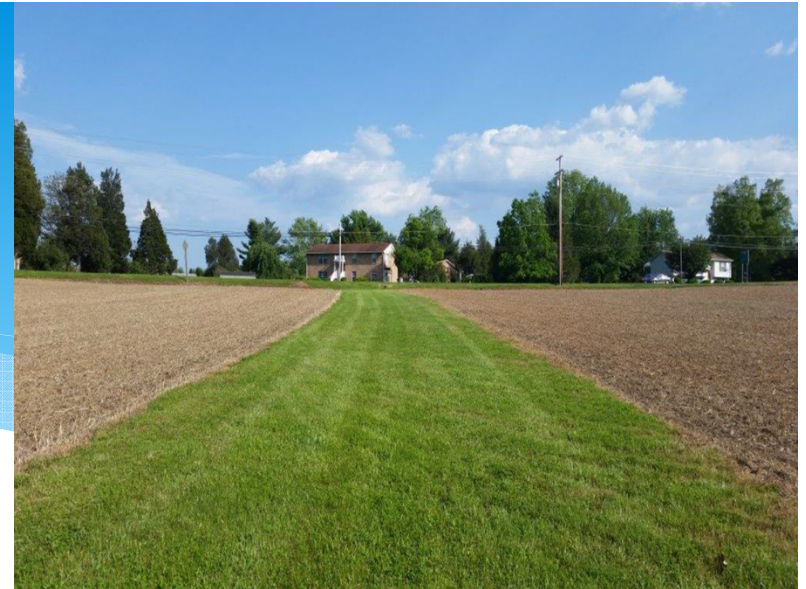
Modified Sand Filters (or the Herring/Frock Method)

- Myron Frock (who had worked with S.C.S. for many years) pointed out that grassed waterways used in agriculture to prevent soil erosion in fields also proved remarkably effective at filtering the water, particularly when underlain with drain “tile.”
- The typical agricultural waterway consists of a perforated HDPE pipe surrounded by 4-inches to 6-inches of stone and overlain by sod.

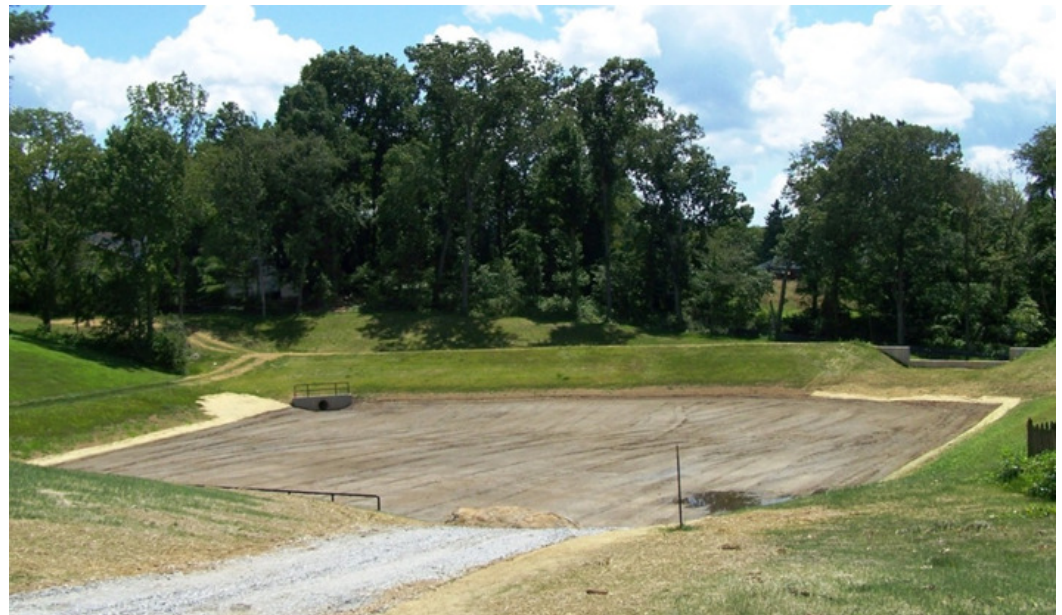
Carrolltowne 2A

2.5” Volume Sand Filter

Completed: 2013

Drainage Ares: 88 Acres

Impervious: 34 Acres (~39%)

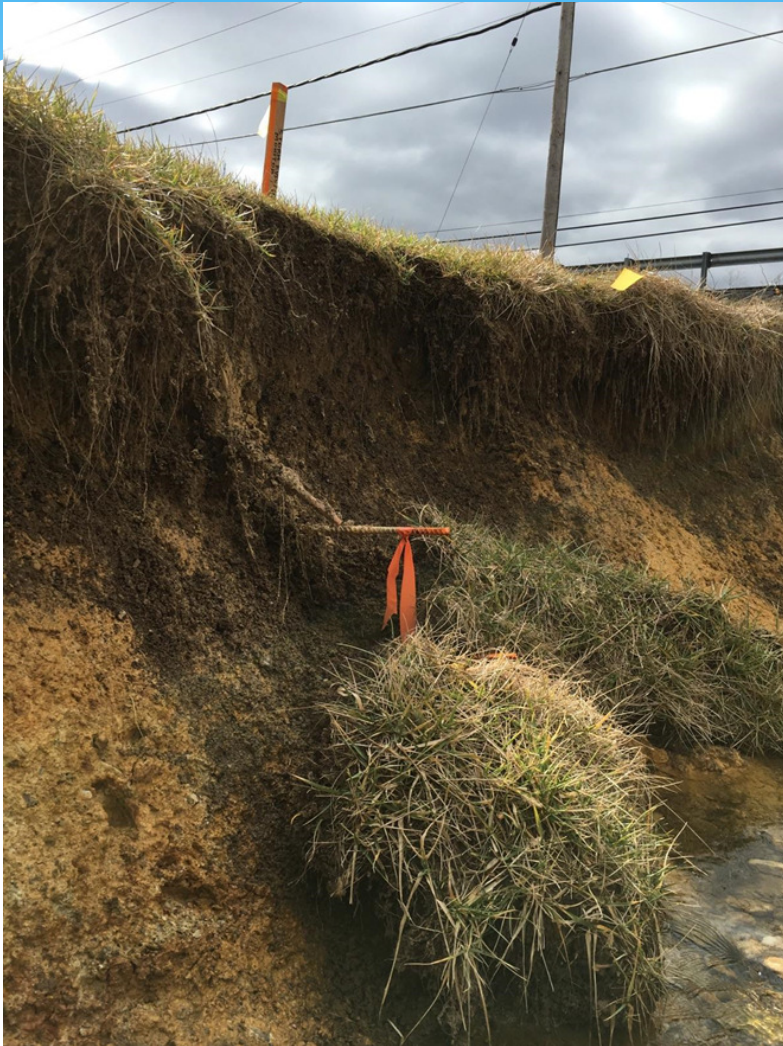
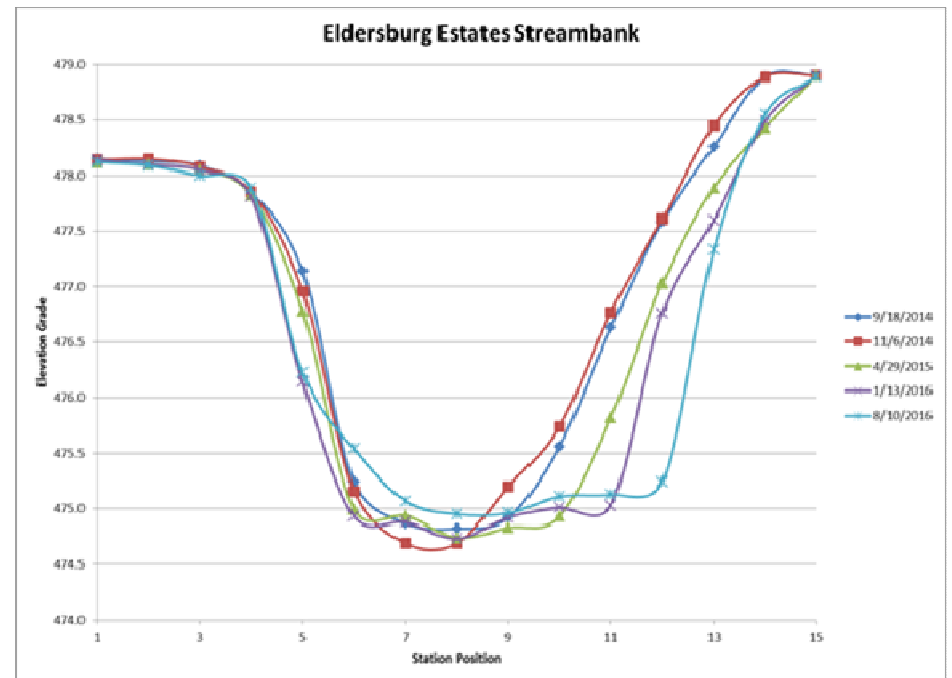
Stream Channel Stability

- Cross Section Surveys
- Bank Pins
- Stage Height Analysis

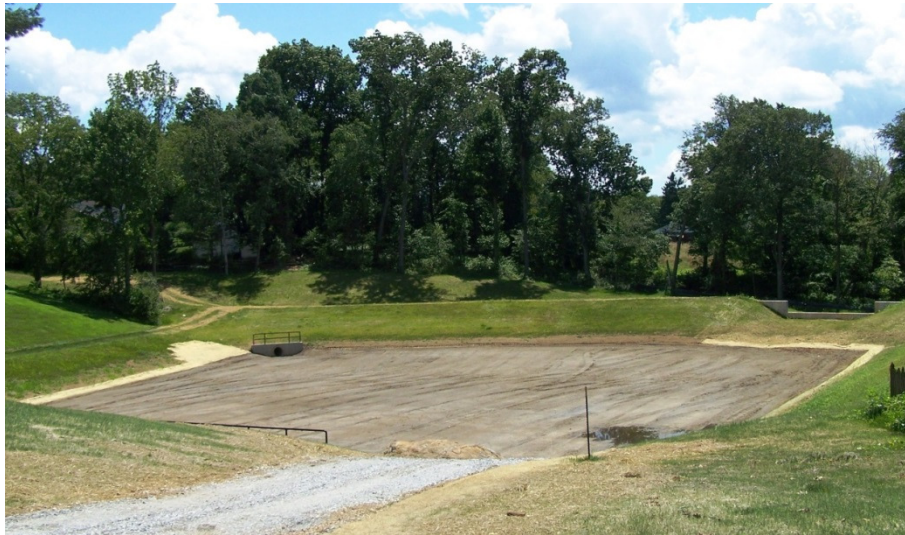
Carrolltowne 2A

2.5" Volume Sand Filter

Completed: 2013

Drainage Area: 88 Acres

Impervious: 34 Acres (~39%)

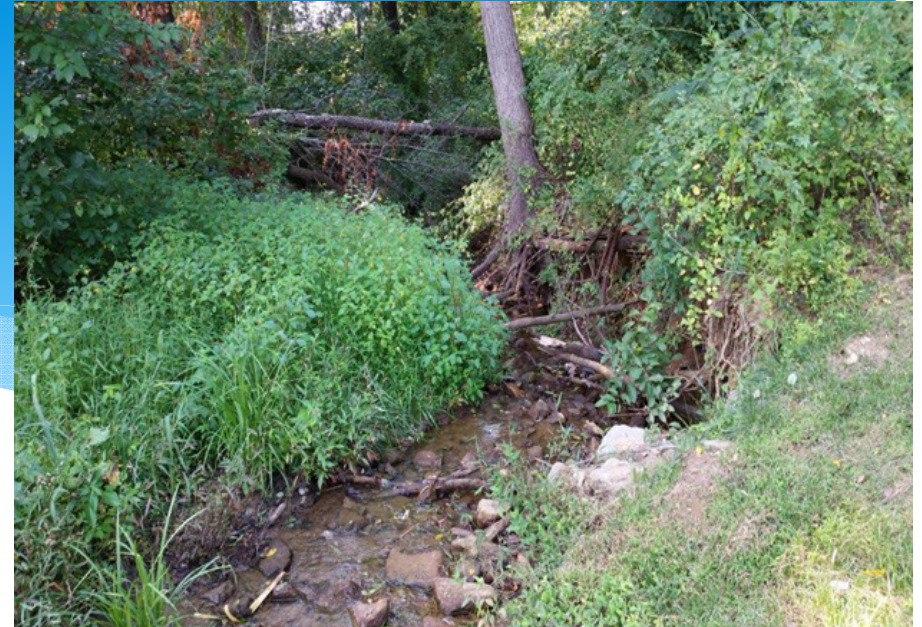
Spring MBSS

2011: 2.67 - Poor IBI

2014: 3.33 – Fair IBI

2017: Sampled March, 30th

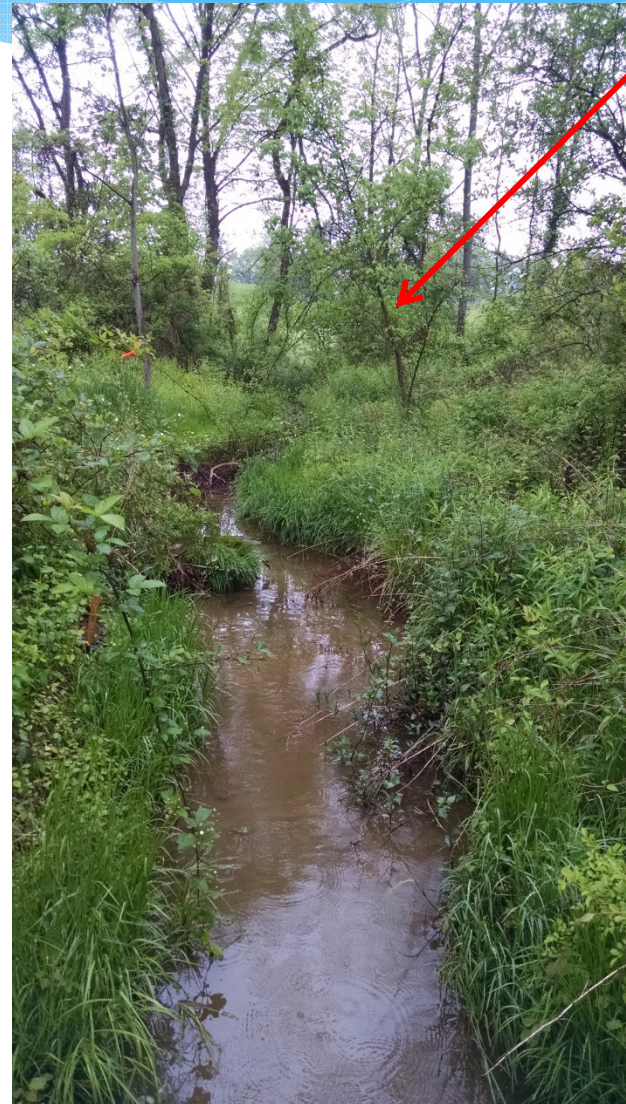
Upstream
