Chasing Compliance: Baltimore's Use of IDDE Methods for Bacteria Reduction

**Van Sturtevant and
Bilal Sarayra
Department of Public Works
City of Baltimore**

June 2016

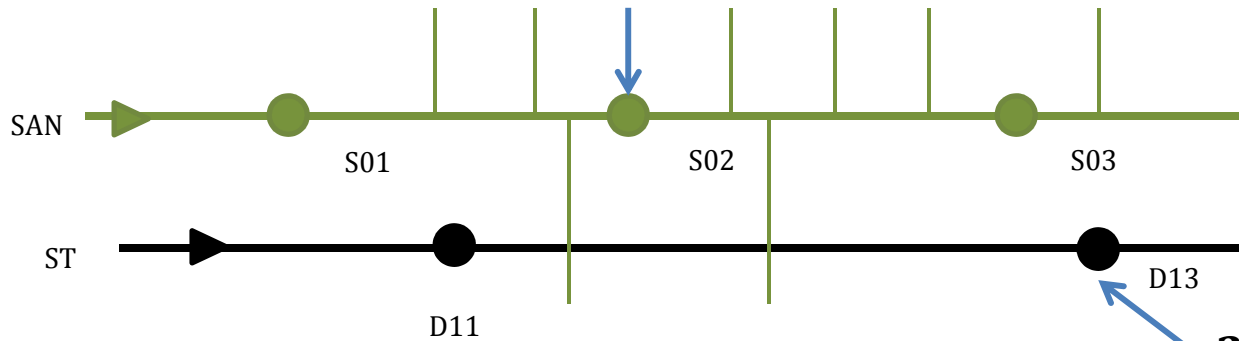
Traditional Dye Testing

1. Single dye deployment here

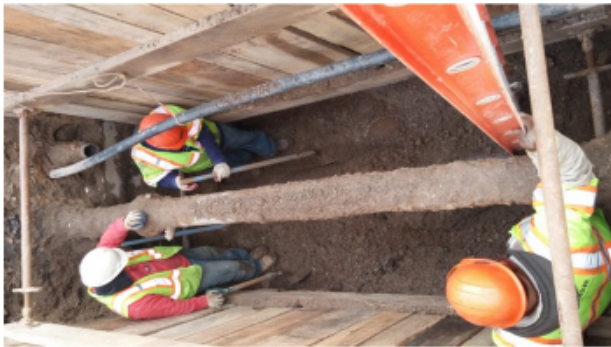
2. Dye viewed here within a short timeframe.

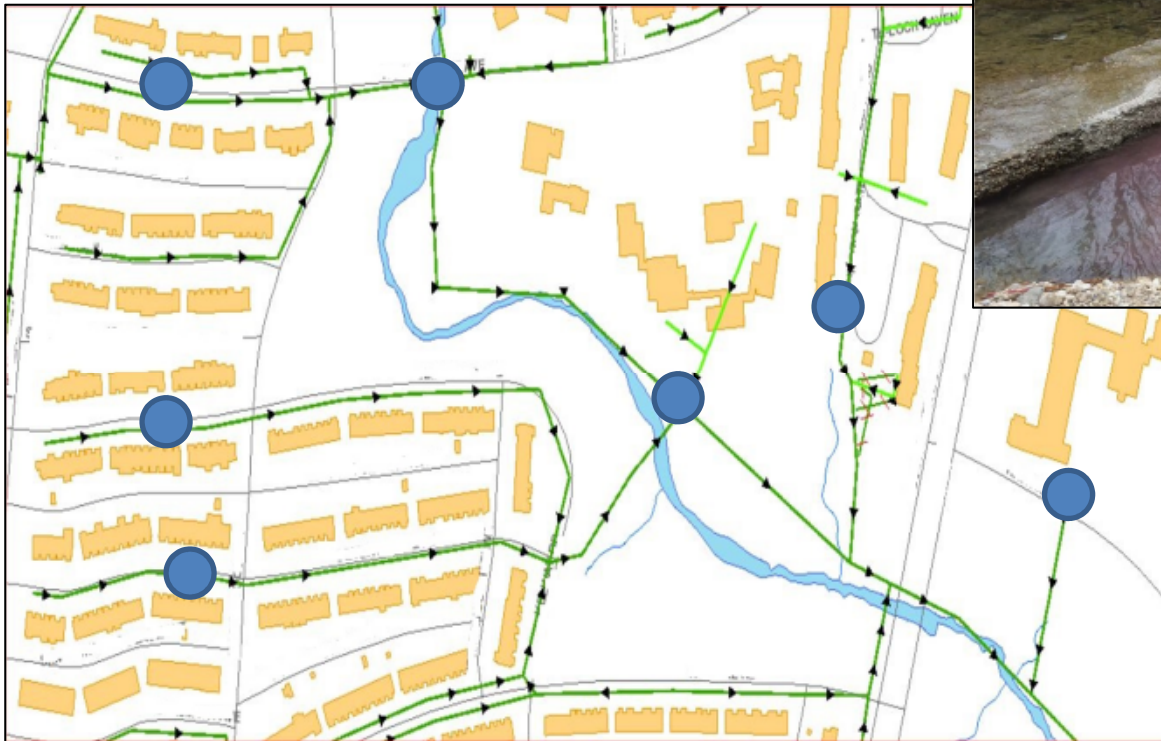
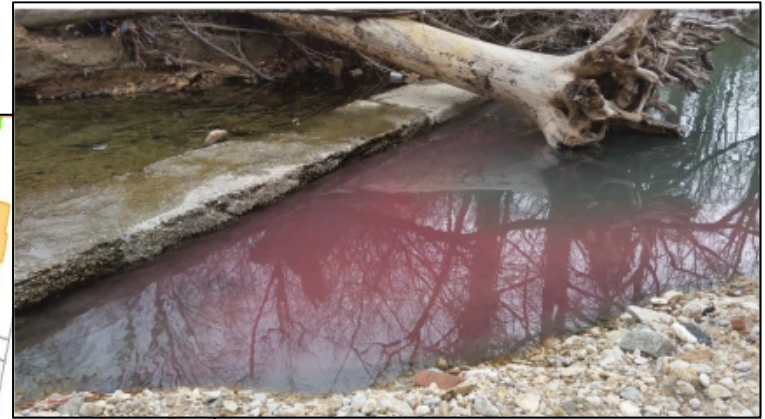
Alternate 1: Mass Dye

Example:
Small leak with a 130-
acre drainage area.
Discharge in stream,
not storm sewer
system.

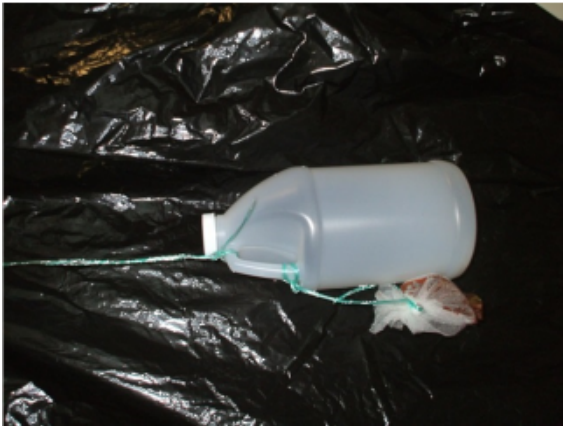
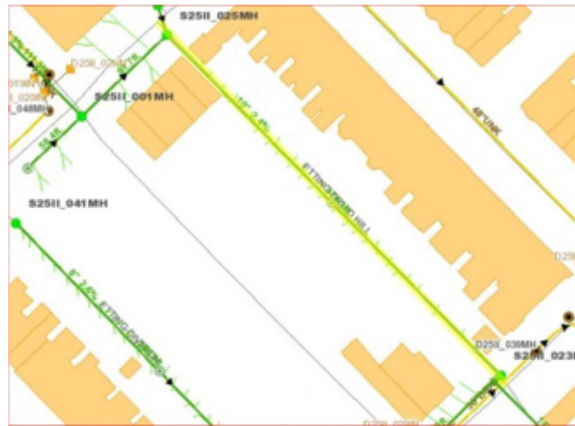
Alternate 2: Segmental Dye

1. Deploy dye bag here

2. Move dye bag here

4. See dye here

Example: 370 LF previously lined 14-inch sanitary pipe, where CCTV showed no defects

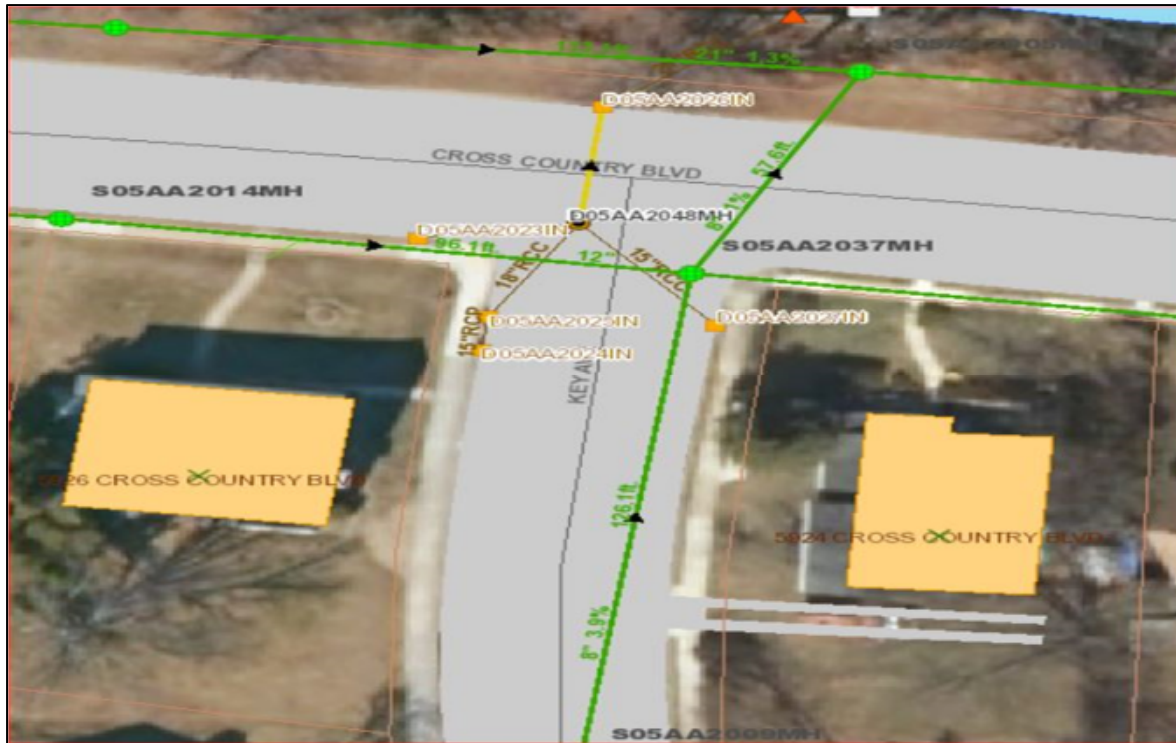
Alternate 3: Long Term Dye

Example:
Closest sanitary asset was not the source.

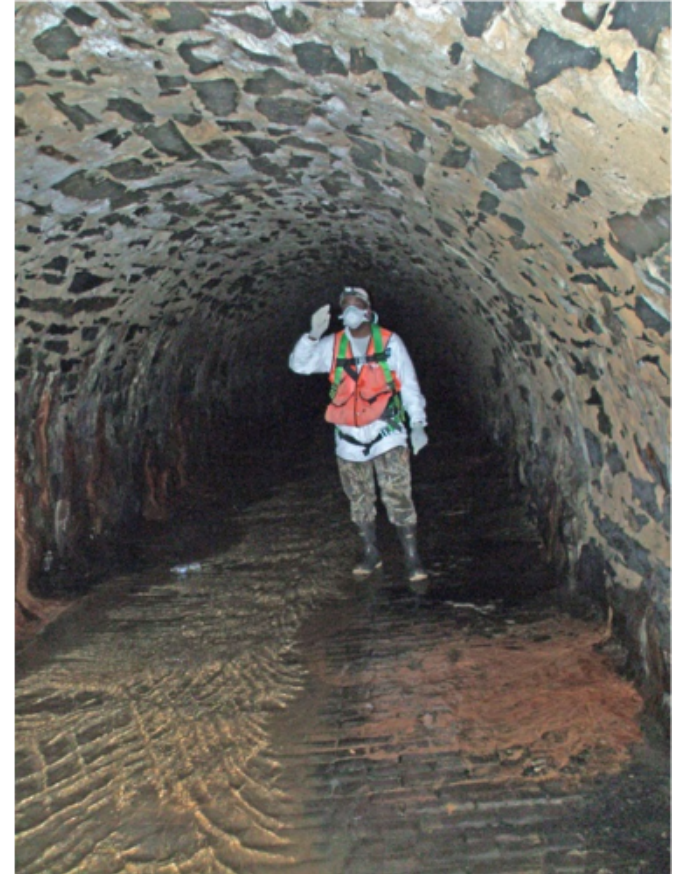
Visual Assessment

- Storm System
 - Pipe walk with Go Pro
 - Pole camera
 - Push camera
 - Pipeline camera (crawler)
 - Camera locator
- Sanitary System
 - CCTV truck
